ALERT: 01-27

EMPLOYEE KILLED WHEN GANTRY CRANE STRIKES RISER SKATE

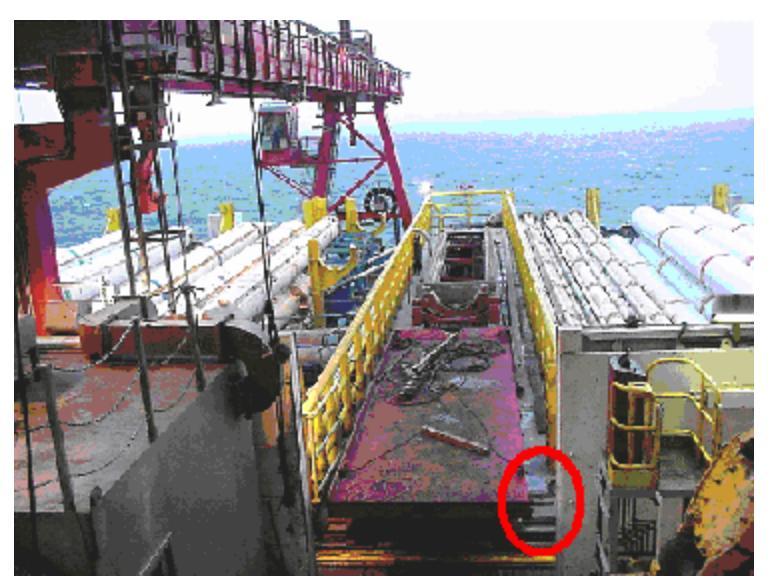
Once he neared the skate, the crane operator then hoisted the load to an adequate height to clear the catwalk handrails. As he did, and even though he was still starboard of the center of the skate, it became apparent the load would not be centered forward / aft over the upper bucket on the skate. He was still several feet starboard of the skate at the time. Although the hooks are controlled independently and have the ability to move forward and aft to some degree, the crane operator did not feel he would be able to center the load onto the bucket without moving the whole skate assembly. He then called the drill floor and requested the driller to move the skate assembly forward. The driller in turn instructed the AD to move the skate, which he did, actually positioning it over the forward gantry crane track, extending through the V-door, into the rig floor. It was not recognized that it would be impossible to accomplish the job with the skate positioned as it was. It also was not recognize that the independently driven upper bucket was all that needed to be moved instead of the entire riser skate assembly.

Prior to this operation, the truck adapter had been installed for transferring various equipment and was still in place. Due to the forward end of the skate being positioned into the rig floor and the additional width of the truck adapter, the space between the Vdoor and skate was reduced to the point employees had to turn sideways to pass from the rig floor to the riser catwalk.

As the skate now covered the forward crane track blocking the crane from continuing over the center of the skate, the crane operator continued to move to port and was concentrating on centering the load in order to lower onto the bucket. He was unaware the forward crane track was obstructed by the skate assembly.

The deceased employee had traveled from the main deck up to the rig floor to help unhook the load once it was placed onto the skate. As he passed through the V-door, the gantry crane collided with the riser skate, knocking the skate off its tracks and into the employee. He was pinned between the truck on the riser skate and the V-door.

- Verify that key HSE management elements related to job planning (JSA, pre-tour / pre-job meetings, use of operational procedures, etc.) are understood and working effectively.

- When a job scope changes or additional personnel are needed to complete the job, the job plan information must be clearly communicated to personnel that have joined the job after the initial planning process.

- Ensure that the processes are effectively implemented to monitor work practices and conditions, and to reinforce safe behavior, and correct at risk behavior and conditions.

- Ensure that each employee understands and exercises his/her obligation to observe for and identify unsafe acts or conditions and interrupt any unsafe operations.

- Perform formal HAZARD Identification exercises for high-risk equipment systems and areas. This is
 especially critical for equipment systems and areas that have prototype equipment, a high degree of
 automation, and / or where equipment from various manufacturers combine and interface to make
 up the system.
