## ALERT 02 – 18

## HANDLING BOTTLE RACK RESULTS IN CRUSHED FINGER

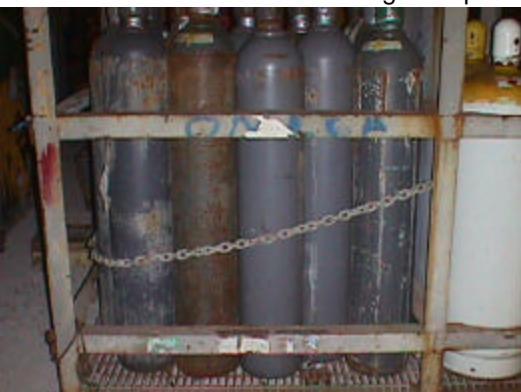
During a material handling incident a worker sustained a crushing injury to the tip of the 5<sup>th</sup> finger of his left hand. The worker was guiding a bottle rack that was being offloaded by a crane from the boat to the ground. The bottles in the rack were loosely secured with a chain and shifted when the rack was set on the ground. The shifting bottles caught the 5<sup>th</sup> finger on the left hand and it was crushed between one of the bottles and the angle iron frame of the rack. The skin and nail in the wound area from just above the fingernail was removed. A skin graft had to be applied to close the wound area due to contamination of the excised skin and nail tissue.

- The employee was holding on to the frame of the rack with his fingers positioned inside the bottle rack instead of out side the frame.
- The bottle rack was of an old design that did not allow the bottles inside the rack to be securely positioned in place to ensure the bottles would not shift during transport.

- It was recommended that the bottle rack should be taken out of service and repaired or redesigned to secure the bottles to prevent shifting during transport.
- A safety meeting on pinch points was conducted for all crewmembers to reemphasize the dangers of pinch points.
- Check all loads for potential shifting cargo prior to commencing the lift.
- Employees were reminded to use tag lines to guide loads into position when appropriate or to use the palm of the hand and not extend fingers into possible pinch points when a load needs to be guided into position.
