Safety Alert

ALERT 06 – 37

SLIPS KNOCKED OVER RESULTING IN LTI FOOT INJURY

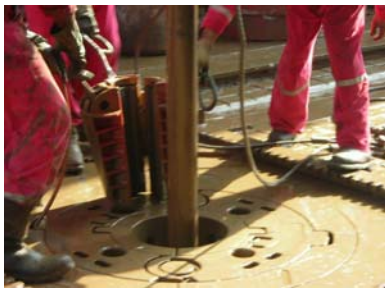
Figure 1

The IP's tasks were to set and remove slips, and ensure the elevator cable was clear of the pipe when pulling to the next tool joint. **Fig. 1** above shows how the elevator cable can easily snag the slip handles. This possibility should have been identified with risk mitigated by relocating the cable to ensure it did not interfere with the slip handles. **Fig 2** indicates the IP's position with his back to the rotary table and preoccupied with the elevator cable. The IP was not aware of impending hazard.

Focus on Behavioral Modification by use of PTW, JSA, and Basic Safety Tools. JSA, reviewed at pre-job meetings should be modified as necessary in the event of change, and reviewed by relieving crews. All personnel should be fluent in the language and process of risk assessment.

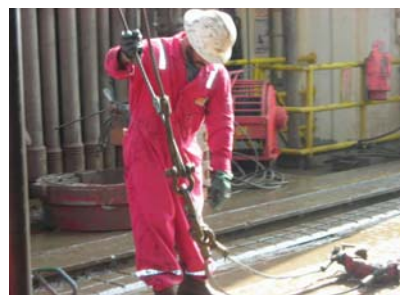
Figure 2

The tubing had square-shouldered tool joints which occasionally snagged the automated slips and lifted them out of the table, so it was decided to use manual slips.
