Safety Alert

ALERT 07 – 39

WIRE ROPE PARTED RESULTS IN A HIGH POTENTIAL NEAR MISS

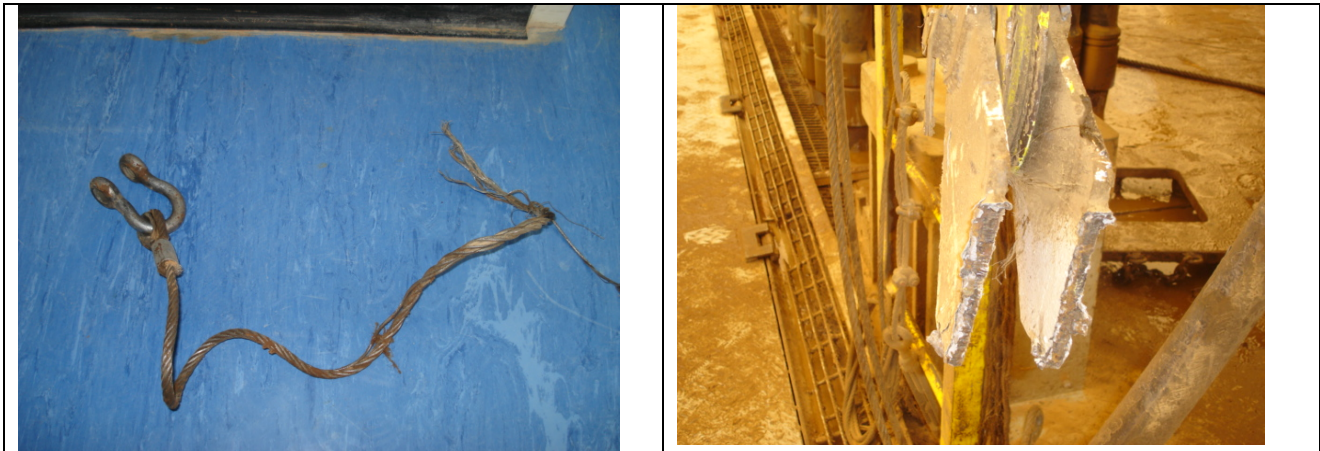
While racking back a stand of 6-1/2" drill collars, the winch line used at the monkey board to rack the drill collars parted. This allowed the collar to swing into the back of the derrick and in the process struck the rig tong cable sheave bracket. After the Driller began lowering the blocks the bracket itself dropped to the rig floor from approximately 20 meters (66 feet). The vibration from the derrick aided in breaking the remainder of the bracket weld off. No one was aware of this until the bracket actually fell. No personnel were injured. The bracket fell approximately 2 meters (6.6 feet) from one a floormen.

- The Derrickman needs to remain alert while watching the winch line.
- Winch line was in bad condition.
- OEM welds on the sheave bracket were of poor quality.
- No safety lines were installed on the sheave.
- There was no proper way of rigging up safety lines on sheaves, ie, no pad eyes or holes to place a safety sling through at the time.

- Repairs to the bracket will be made as soon as possible depending on the rig operating schedule.
- Safety sling on Driller's side bracket installed temporarily until pad eyes or holes can be completed.
- Weld a pad eye on each sheave bracket to allow for proper rigging up of a safety sling, or drill holes in the brackets to accommodate a safety sling.
- Engineering (modification) requests are to be submitted for any alterations to be completed on sheave brackets to install safety cables.
- Crew must keep Job Safety Analysis (JSAs) current.
- Crew Safety Meetings will be scheduled to review serious incidents such as this.
