Safety Alert

ALERT 07 – 09

DROPPED OBJECT RESULTS IN SERIOUS NEAR MISS

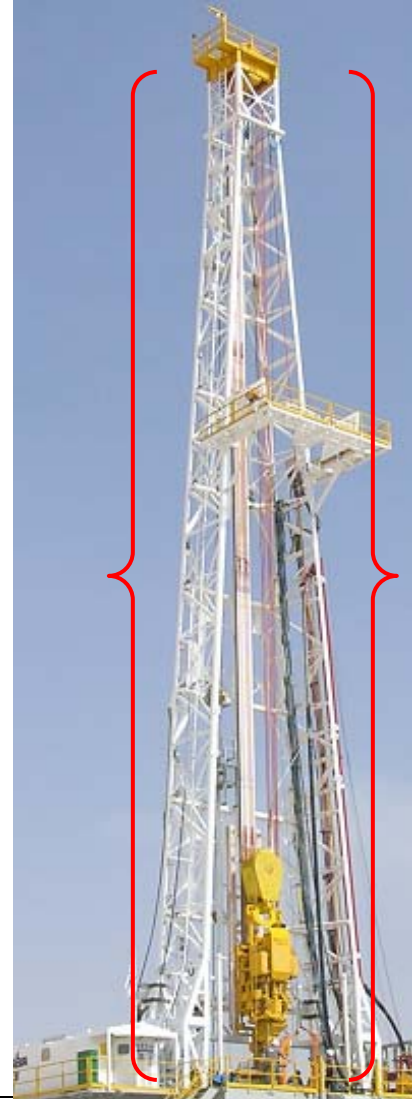
- Poor inspection practices conducted on the Rig
- Safety pin may not have been installed on the four-part shackle, as required.
- Safety procedures for proper installation of equipment were not followed.

Incorrect Shackle

Correct Shackle

- Rig Managers and Safety Officers are required to acknowledge in writing to the Area HSE Department that only four-part shackles are being used on the rig floor and on the mast.
- Weekly rig inspections must be carried out and documented on all shackles, as well as any other potential dropped object.
- Routine visual inspections can eliminate the potential hazard of equipment and fixtures from coming loose and falling.
- Do not use shackles that are damaged or missing any of the four parts.
