Safety Alert

ALERT 07 – 15

STRINGING UP DRILL LINE RESULTS IN LTI

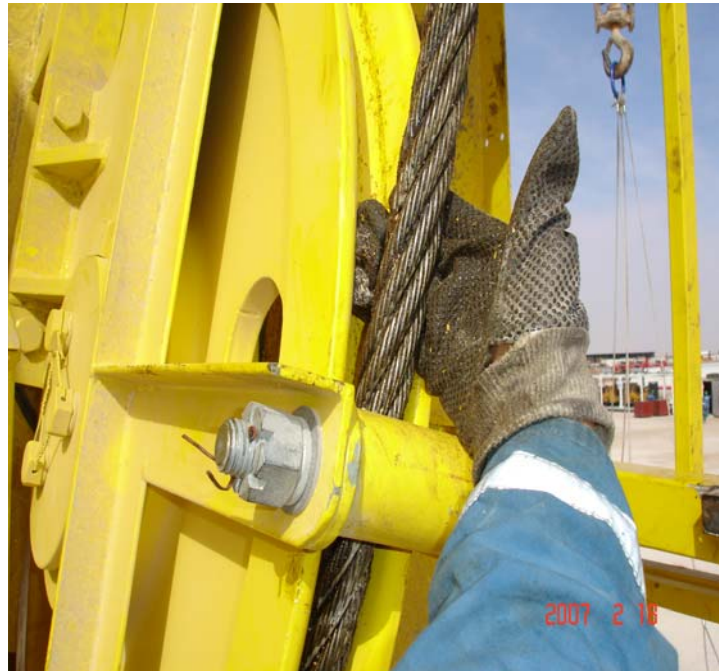
While stringing the drill line on a new rig, the injured party (IP) was 'pulling' or 'guiding' the deadline between two crown sheaves. At that time, the IP's fingers on his right hand got caught between the deadline and the keeper guard. The result was the amputation of two finger tips on his right hand.

CORRECTIVE ACTIONS: To address this incident, this company instructed Rig Supervisors' in the following:

- Better planning of critical tasks is required by Leadership.
- A thorough JSA must be conducted with all Rig Supervision and personnel involved in the job being performed.
