Safety Alert

ALERT 08 – 13

IMPROPER ATTACHMENT OF SAFETY LINE RESULTS IN A DROPPED OBJECT

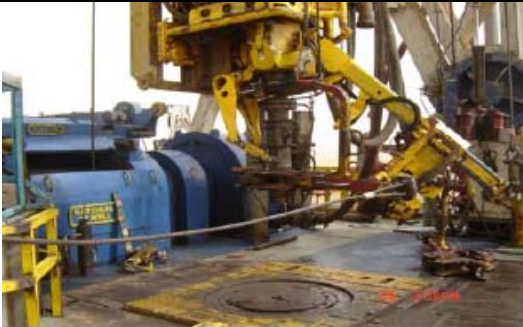
The make – up tong was used to hold the lower IBOP while they torque the upper IBOP in the reverse direction

1. The pipe handler is to be used for breaking /making up the IBOP connection.
2. Make sure that the pipe handler clamp cylinder pressure is 2000 psi and the dies are in good condition.
3. In case of using rig tongs for breaking the IBOP or saver sub from the main shaft, it's important to use a pup joint in order to maintain it in the center and prevent the twisting motion.
4. Any non-routine job related to the TDS should be performed under the supervision of the Rig Senior Mechanic and Senior Toolpusher.

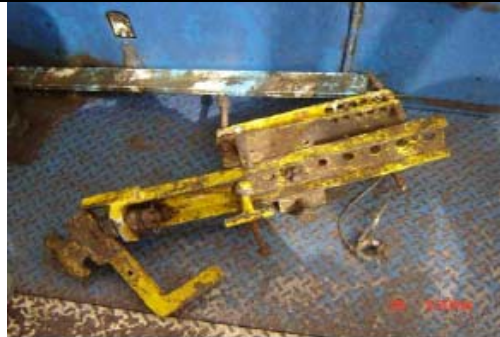
The intermediate tieback (Approx. 12kg) was fell from 10 meter height to the rig floor

- Night Pusher and Driller did not comply with the procedure for breaking out the IBOPs from the Top-Drive System.
- This was the first time to do the job with one tong which is a short cut for breaking out the lower and upper IBOPs.
- This shortcut was taken without authorization or advice from the Senior Toolpusher.
- Incorrect securing for the intermediate tieback was made on the mast beam with the securing wire wrapped around the intermediate tieback itself instead of being wrapped around the mast beam as was required to prevent a dropped object.
- Improper tieback allowed the tieback beam to fall from 10 meter
