Safety Alert

ALERT 09 – 02

DROPPED OBJECT – PAD EYES FAIL CAUSING NEAR MISS

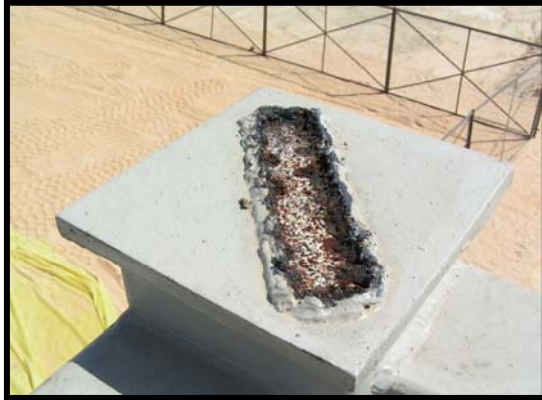
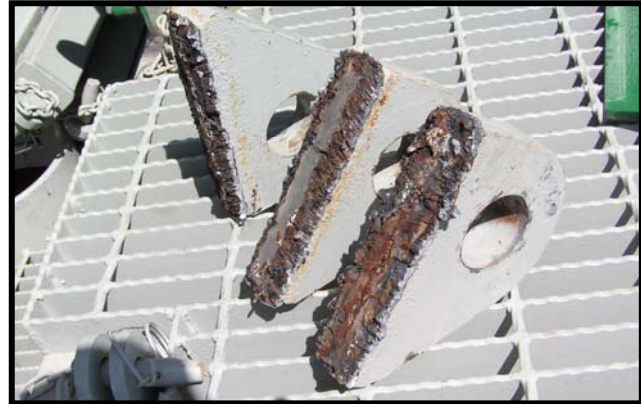
When lifting a newly constructed mud cleaning equipment skid for installation on a mud tank, three of the four lifting lug pad eyes failed at the welds located on the top of the Mud Cleaning System Lifting Frame. The skid fell to the ground. The shaker skid was approximately two feet off the ground when the welds failed. Fortunately, the crew members were using tag lines on the equipment and were at a safe distance from the lift. No injuries sustained and no equipment damaged.

- Lack of quality control during fabrication permitted a substandard product to enter into service.
- Weld penetration on the pad eyes was found to be unacceptable by standard welding specifications.
- After construction of the skid, inspection of the welds was not thorough nor complete.

- Instructed construction supervisors that all pad eyes used for lifting purposes need to be stamped with a unique identity mark or number to enable tracing of the pad eye to the inspection and certification documents.

- Personnel in charge of reconstruction or construction of skids were instructed to contract a third party qualified welding inspector to visually inspect and verify that all welding of lifting lugs and pad eyes meet the quality standards for welding.

- The company revised engineering and drafting procedures for drawings to include the wording that all critical welds on lifting lugs and base plates as well as other critical welds associated with lift and support structures be inspected by a qualified welding inspector for cracks, fatigue, penetration, etc.

- The company instructed quality control personnel that the Quality Control System needs to be improved and closely monitored.
- The company instructed company personnel in charge of rig construction projects to develop a Lifting Equipment Register and use it to log all pad eyes on the rig as they are welded, inspected and documented prior to leaving the rig up facility.
