Safety Alert

From the International Association of Drilling Contractors

ALERT 09 – 16

EXTENSION CORD SAFETY

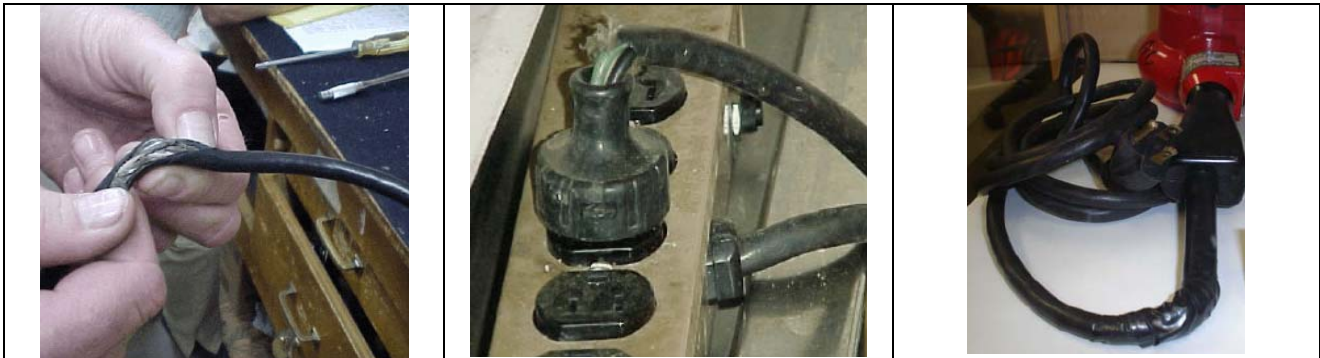
During a routine inspection of a 110 volt coiled extension cord, an Electrician found that one of the leads was damaged.

Extension cords are rated for the current they can carry in free air. If you use an extension cord to full capacity when it is coiled up, the heat trapped in the center of the coil can cause the insulation to break down and melt.

- Reminded all crew members that when using coiled extension cords, the cord **MUST** be fully extended.
- Instructed personnel that when they are using extension cords, they are to ensure that the cord is not caught under equipment that could restrict the flow of free air around the cord.
- Personnel were instructed to take care to ensure that extension cords are not kinked or tied in tight knots.
- Coiled extension cords are also widely used in many household applications, such as gardening, do-it-yourself projects, home shops, etc. Please take this information home and be safe.
