ALERT 10 – 04

LARGE CONTAINER LIFTED BY HELICOPTER DOWNDRAFT

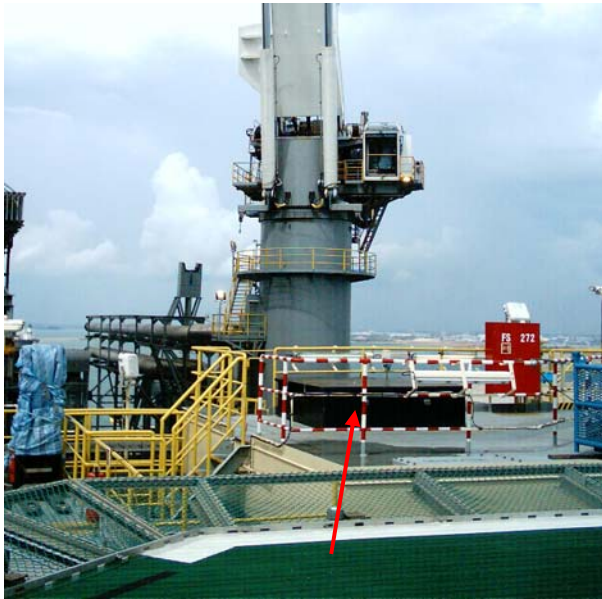
During a scheduled helicopter landing, the helicopter's downdraft caused a large container weighing around 200 kilograms (440 pounds) to be lifted over handrails and then fall around 10 metres (33 feet) to the deck below. The container had been in place for some months and had experienced several similar helicopter landings without incident. The container was placed on the roof of a structure adjacent to the helipad on wooden battens and was not secured. The container was damaged in the fall. While no injuries were sustained, there was significant potential for serious injury.

Location prior to the incident

- The container was immediately removed from the location.
- The container will be replaced and installed with a designed restraint system.
- Lessons can be learned on the hazards that can be created by placing unsecured items, irrespective of their weight, in areas such as helidecks where there is intense airflow.

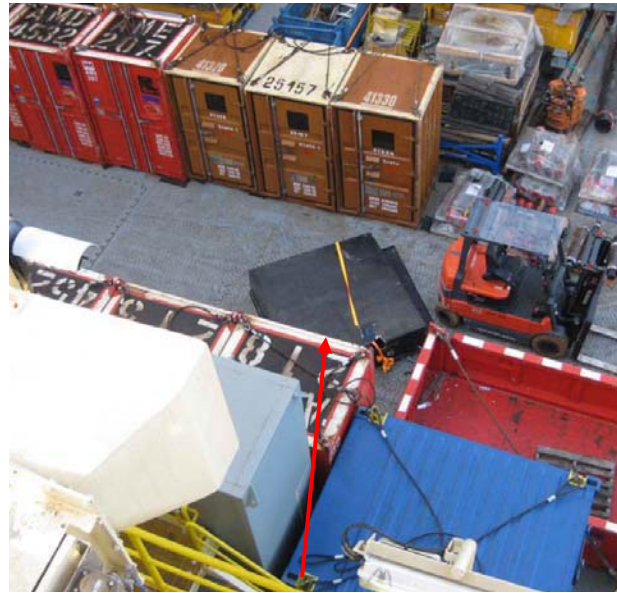
Location after the incident

The container was placed adjacent to the helipad and 35 metres (115 feet) from the helipad centre. The container was mounted on battens, but was not fastened to the structure. These factors promoted the conditions for the rotor wash (air flow created by rotor system) to cause lift and move the container to a point where it fell over the handrail to the deck below. The helicopter in use had a significantly greater rotor wash (air flow created by rotor system) than the other helicopter types that visit the rig.

- All loose items should be removed from the helicopter landing area and containers or storage systems close to helicopter operations should to be secured to a supporting structure.
