Safety Alert

ALERT 06 - 02

SAFETY RETRACTING LIFELINE BLOCKS AND ROTATING MACHINERY

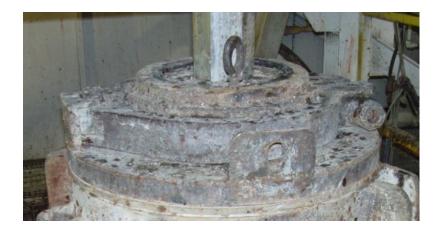
Recently, an employee was fatally injured due to interference between his fall protection equipment and the rotating head atop the annular Blowout Preventer (BOP). Specifically, the employee hooked the Safety Retracting Lifeline (SRL) to his harness and walked laterally across an elevated catwalk to a location where the rotating control device (rotating head) was between the employee and the anchor point of the SRL block. This apparently allowed the line to become entangled in the rotating control device (see photograph).

On this model of rotating control device, the entire clamp assembly rotates along with the kelly. SRL line apparently became entangled in some portion of the clamp assembly.

CORRECTIVE ACTIONS: To address this incident, this company issued the following to rig personnel:

- 1. Personnel shall maintain a 6 ft (2 meter) radius from the BOPs at all times while the rotary is engaged (rotating). If maintenance activities require access to the BOPs, the rotary shall be disengaged and locked out.
- All Rig Managers shall review with crews general precautions regarding the use of SRL blocks. Special
 emphasis should be placed on directing personnel to not move laterally away from the overhead anchor
 point.
- 3. Some models of rotating control devices are designed such that there are no external rotating parts. Use of these devices is encouraged when possible. If a rotating control device with external rotating parts is employed, barricading shall be installed to ensure personnel maintain a safe distance during operation.
