Safety Alert From the International Association of Drilling Contractors

ALERT 07 – 23

CRANE OPERATIONS – DROPPED DOG HOUSE

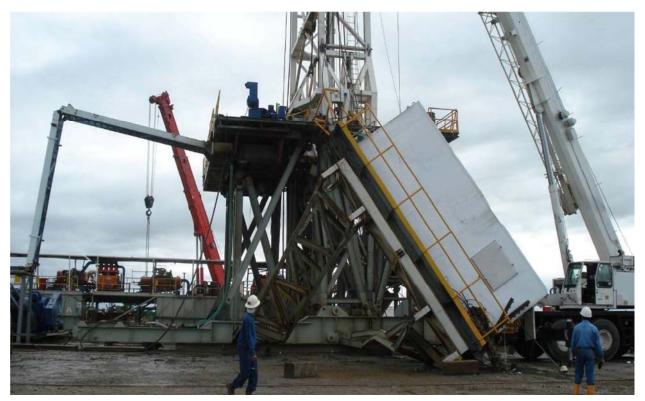
A crew was rigging down a dog house with a 100 ton crane that was subcontracted for the move. After they had removed two pins from the sub floor of the doghouse and the third one was in the process of being removed, the Crane Operator decided he wanted to change out the slings. Without any warning or authorization, the Operator loosened the slings that sustained the dog house on the right side. When the third pin was removed the dog house fell. No one was injured but the equipment was damaged.

The Crane Operator used poor judgment when he loosened the rigging slings without any warning. There was a lack of supervision of the Crane Crew toward the job being performed. A thorough JSA was not performed on the rigging down of the dog house by the Crane Crew.

- Third party operator training must be verified before allowing them to conduct work.
- Reinforce to all personnel involved during a heavy lift the hazards associated the planned operations and conduct a thorough JSA.
- Evaluate subcontractor (Crane operator, Signalman) qualifications
- Clear communications must always take place between the Signalman and the Crane Operator
- Clear communications between the field and the area office must occur at the beginning of every rig move.
- Closer supervision of tasks involving both company and third party personnel.
