Safety ALERT

Cement Unit Agitator Severs Fingers

Alert 1-19

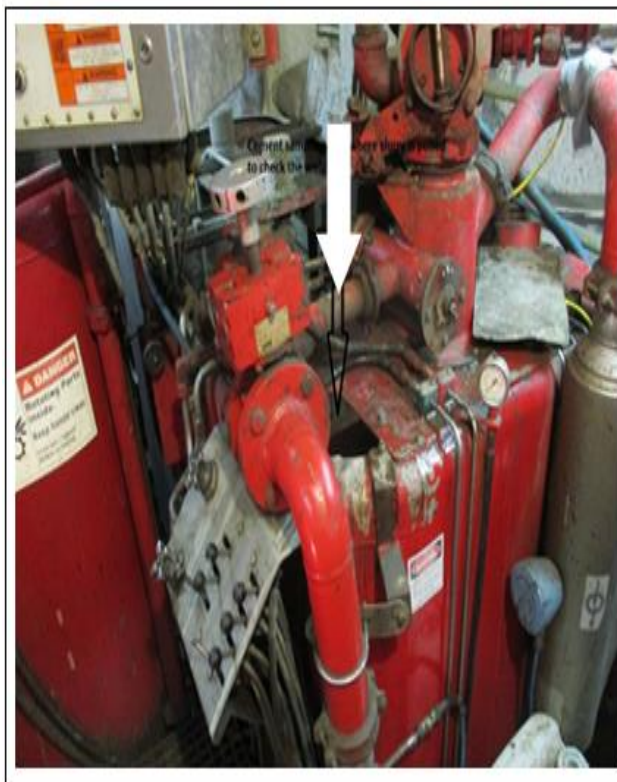
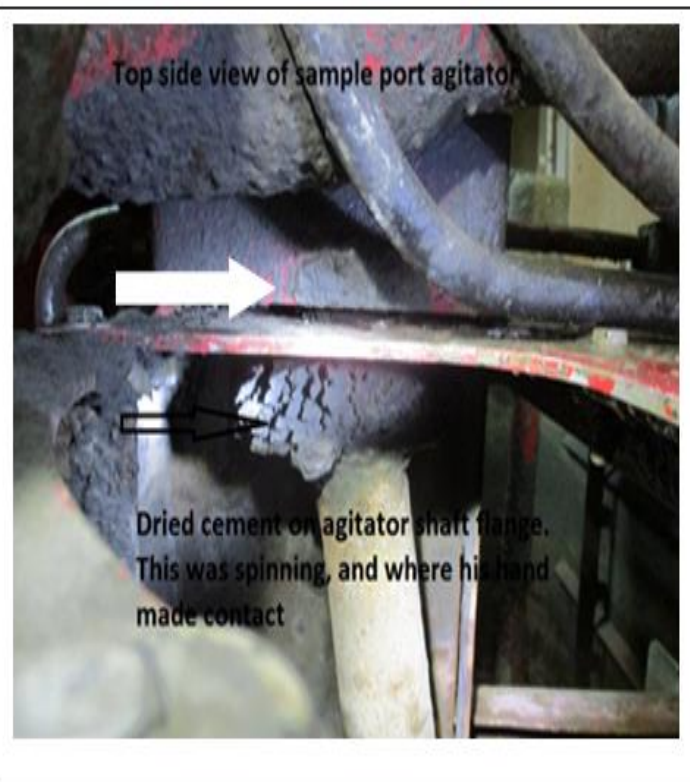
The Cementer and his Supervisor were washing down the cement unit after a 1st stage cement job. The Cementer had his hand in the sampling outlet on the mini batch tank with the agitator running. Dried cement on the upper agitator flange severed 3 of the Cementer's fingers on his left hand. The incident investigation is in progress.

- All persons on the rig shall follow the energy isolation policy when working on equipment.
- Hazards associated with moving equipment should be identified and documented during a pre-job risk assessment.
- Stop Work Authority (SWA) or Time Out for Safety (TOFS) shall be used when any deviation from the risk assessment is identified.
- Guards and covers should be designed and installed to physically prevent contact.
